MACHINE BUILDING AND MACHINE SCIENCE

Morphology and genealogy of structural defects in vacuum ion-plasma coatings

O. V. Kudryakov, V. N. Varavka, I. Yu. Zabiyaka, E. A. Yadrets, V. P. Karavaev Don State Technical University (Rostov-on-Don, Russian Federation)

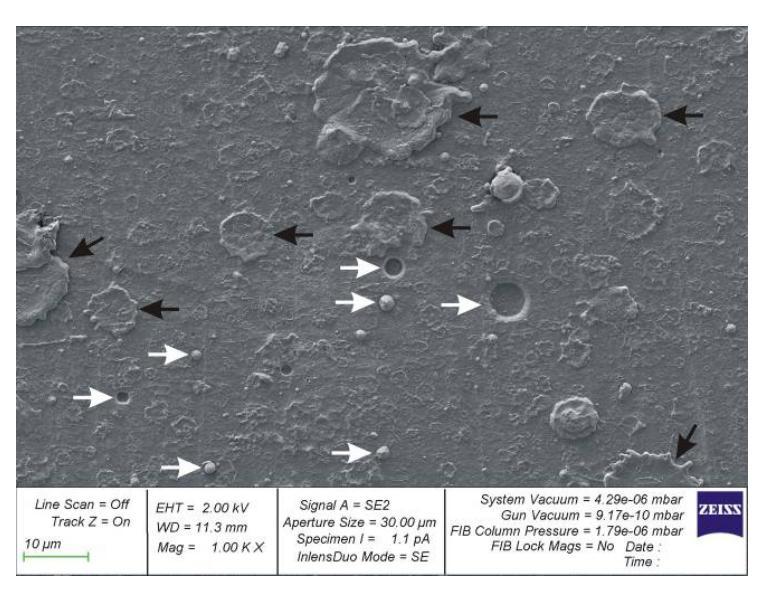
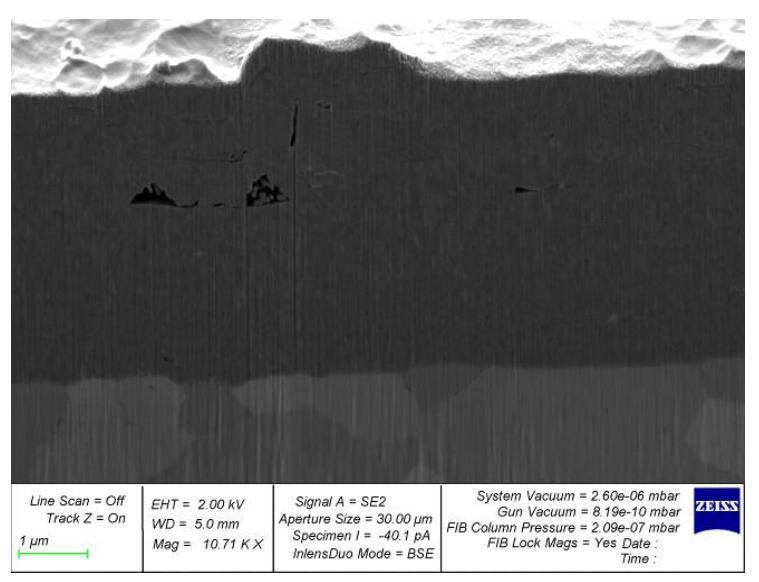
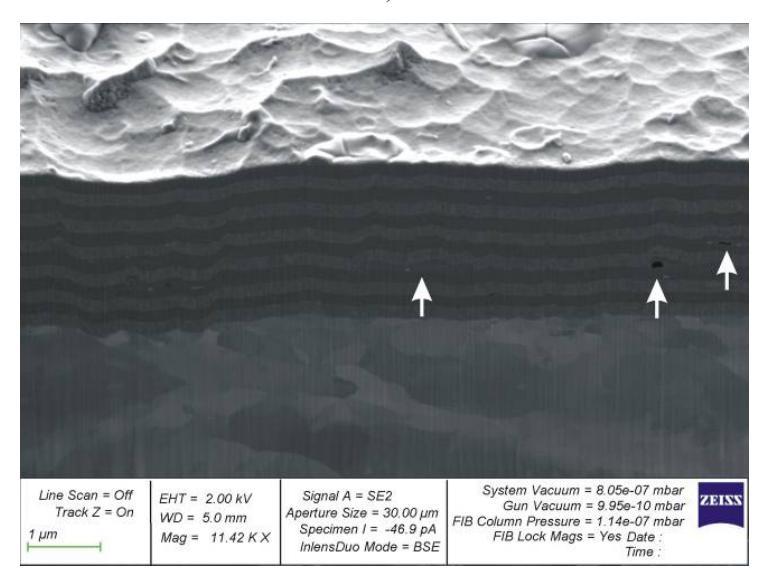
Since the appearance of both types of defects in a specific microvolume of the coating is of a random nature, then, in contrast to "regular growth defects", it is logical to combine them into a class of "stochastic defects". Among them, "droplet defects" are mainly formed when using powerful thermal evaporators of a vacuum installation, as well as during the deposition of fusible coating elements. "Droplet defects" can be almost completely eliminated through magnetron evaporation. Examples of "drop stochastic defects" of ion-plasma coatings are shown in Fig. 1. On the surface, they have a characteristic shape with a flaky configuration, which is marked in Fig. 1 a with dark arrows. Getting on the surface of the coating during its application, the droplet phase violates the laminar dynamics of the normal growth of the coating, which manifests itself in the form of irregular pores in the cross section of the coating (Fig. 1 b). In multilayer coatings, pores and structural inhomogeneity formed in the droplet phase zones can have an elongated shape at the boundaries of the coating layers during the transition from a layer with refractory components to a layer with a fusible element (Fig. 1 c).

Fig. 1. Examples of droplet defects in TiAlN coatings, SEM: (*a*) on the coating surface (marked with dark arrows); (*b*) in the cross section of a monolayer coating; (*c*) in the cross section of a multilayer coating (marked with light arrows)

Examples of the studied defects of substructural origin are shown in Fig. 1 *a* (marked with light arrows) and in Fig. 2. They have a characteristic geometric shape. In the body of the coating, there is a cylindrical part of the defect, and a conical part protrudes above the surface of the coating. Under certain conditions, the formed defect is rejected through undergoing extrusion, i.e., extrusion by the coating, leaving cylindrical depressions of the correct geometric configuration in place of its localization. If the coating process continues, the cavity is filled with the deposited ions of the coating material at a higher rate than the rest of the flat surface. This is probably due to the "edge effects" of the electromagnetic field formed by the bias voltage on the substrate. As a result, the cylindrical depressions are "healed" during the application process, and the coating is sufficiently uniform in this area. If the considered defects are extruded from the coating immediately before the end of the process of its application, then the remaining cylindrical niches are clearly visible on the surface (Fig. 1 *a*, and 2 a - 2 d).

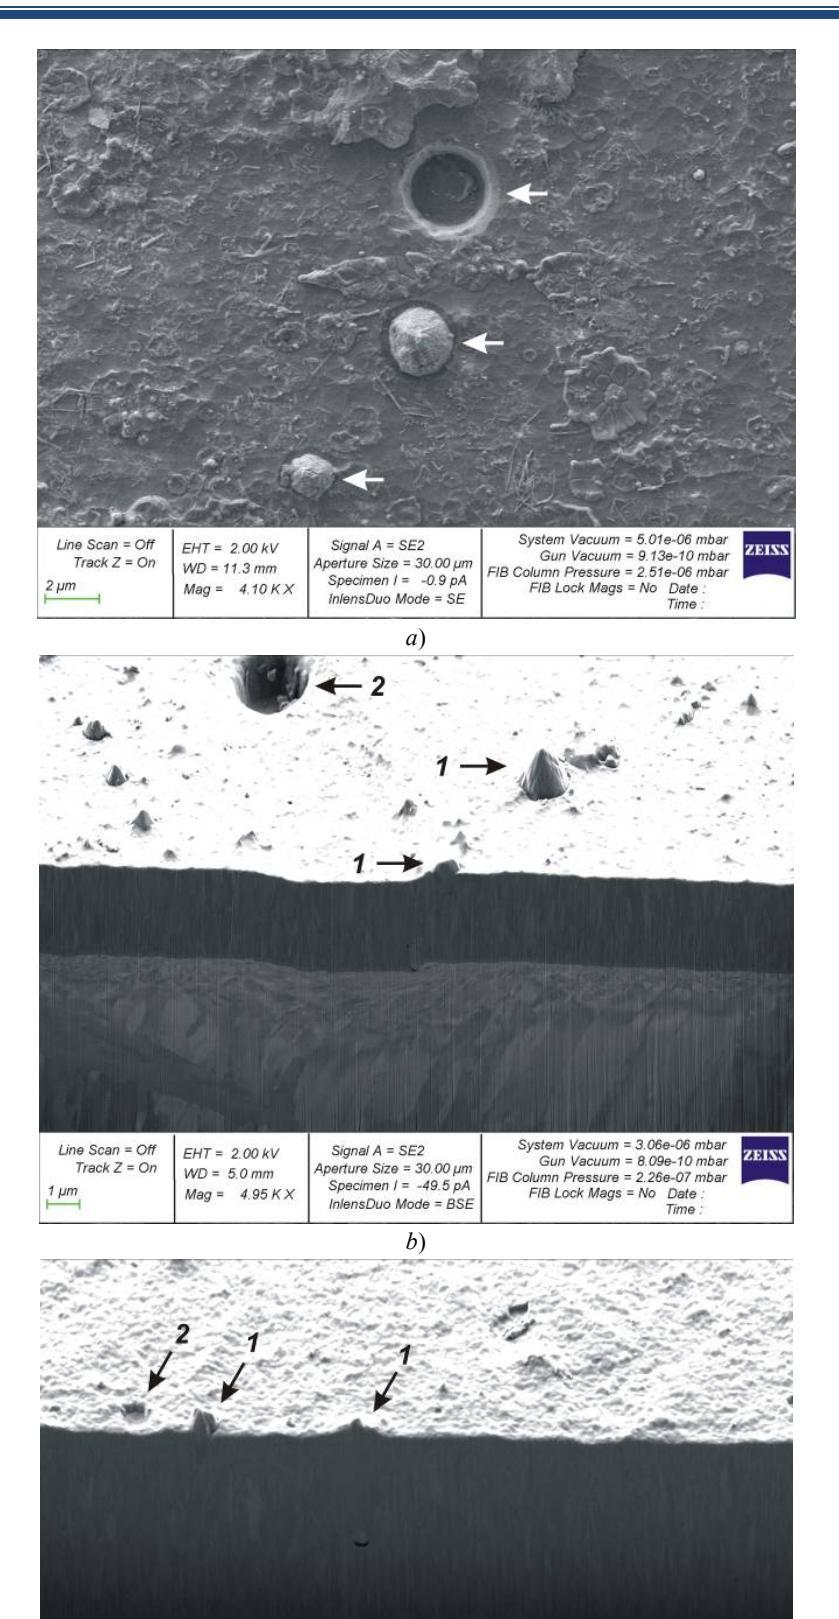
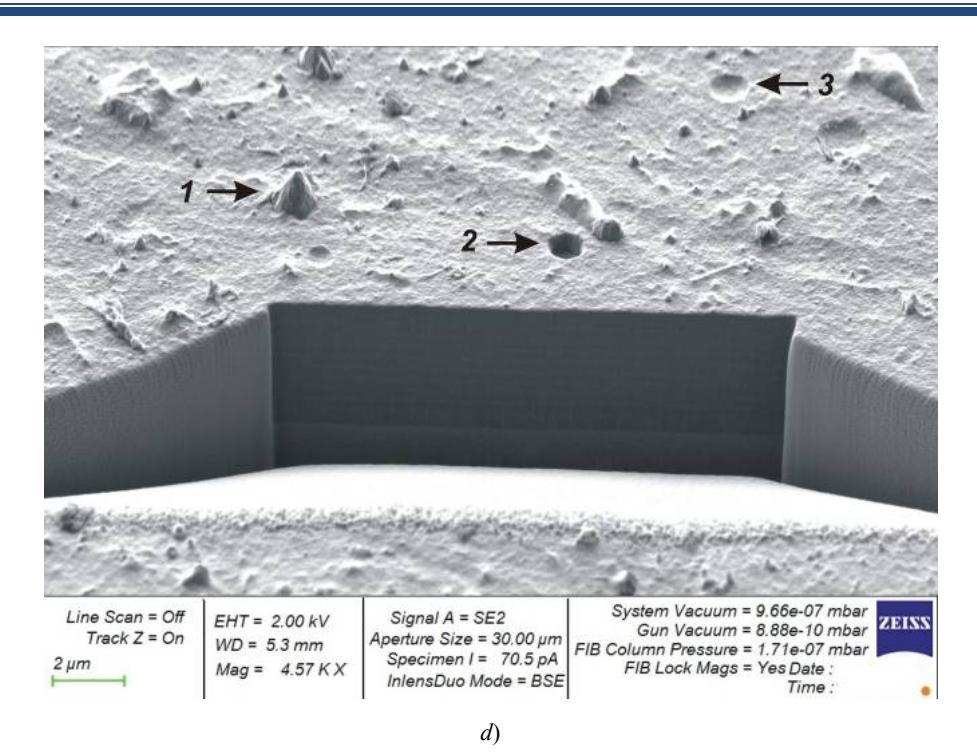
Fig. 2 shows a complete microscopic picture of various stages of the life cycle of substructural defects in the PVD coating of the Ti-Al-N system. Normal projection shows three defects of different sizes located at a distance of several micrometers from each other (marked with arrows). The conical shape of the protruding part of localized defects and the cylindrical niche of the extruded defect are clearly visible. In Fig. 2b - 2d, these stages of the existence of defects are presented in a three-dimensional picture. Conical "heads" protruding from the coating are designated by number 1, cylindrical niches — by number 2; and number 3 in Fig. 2 d, shows the place of the niche at the stage of "healing". The volumetric image was obtained through preparing the FIB cross-section, perpendicular to the coating surface, and then tilting the sample towards the detector by $15-28^{\circ}$. Fig. 2 b, 2 c, show only the cross section of the coating and its surface, and Fig. 2 d — the entire cross-section in block. The preparation of cross-sections provided obtaining a cross section of the investigated defects (Fig. 2 b, 2 c). It is clearly seen that their lower base is flat, being located inside the coating at different depths, and morphologically not related to the coating structure or to the substrate relief. Almost all visible in Fig. 2 defects have different diameters and heights, while the angle at the apex of the conical "head", i.e., the ratio of its diameter to height, changes insignificantly. This suggests that defects grow as the coating grows. Defects originate at a certain point on the surface of an already existing "growing" coating and subsequently increase their diameter and height further on with time. The growth of the coating and the defect occurs simultaneously and at the same rate, with the exception of the advanced growth of the "head" of the defect, since until the moment of extrusion, the "head" has to always be above the level of the coating surface.

Fig. 2. Substructural defects of ion-plasma TiAlN coatings, SEM: (a) on the coating surface in normal projection (marked with arrows); (b)–(d) on the surface of the coating and in cross-sections FIB

These features of helical growth suggest that the considered defects of ion-plasma coatings (Fig. 2) are formed at a high growth rate. This is indicated by the cylindrical shape of their "base" recessed into the coating, and a sharp conical shape of the "head" protruding above the coating surface. These geometric features also assume enrichment of conical crystallites in one of the coating components. Apparently, the higher growth rate of the spiral faces of the considered defect in comparison with the surrounding volume of the coating is the key reason for the isolation of the considered substructural defects in the coating and their subsequent extrusion.

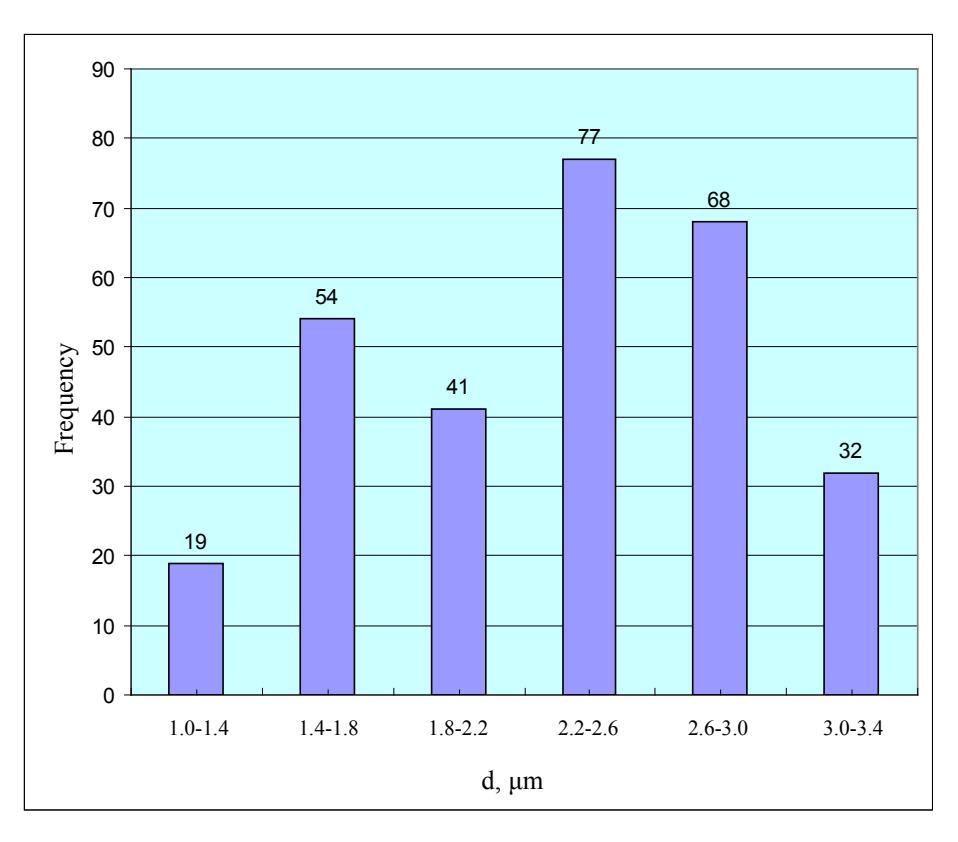
Statistical data on the geometric characteristics of substructural defects in the Ti-Mo coating are shown in Fig. 3. Under the statistical analysis, the maximum diameter of the "head" measured over the coating surface was considered as the diameter of the defect d.

Fig. 3. Diameter *d* distribution of substructural defects in Ti-Mo coatings

The scatter of *d* values is quite significant and amounts to $0.95 - 3.3 \,\mu\text{m}$, the average value is $d_{cp.} = 2.26 \,\mu\text{m}$. For coatings of the Ti-Al-N system, the values of similar statistical parameters are: $d = 1.2 - 4.0 \,\mu\text{m}$; $d_{cp} = 1.91 \,\mu\text{m}$. The average statistical value of the parameter d/h_0 , where h_0 is the height of the conical "head" of the defect protruding above the coating surface; for all studied coating compositions was 1.48, which corresponds to the angle at the apex of the "head" cone — 73°.

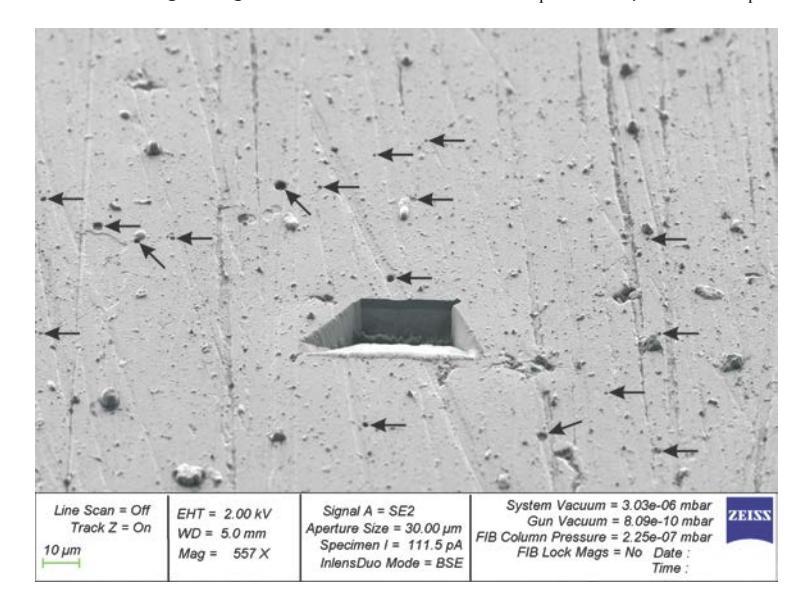
A similar statistical analysis based on the results of electron microscopic studies of the diameters of extruded defects (niches) d_e , has shown that the spread in d_e values is too large to assert that the extrusion of a defect occurs when a certain fixed critical value d_e is attained. Fig. 4 shows that in the coating of the Ti-Al-N system there are extrusions of various diameters, whose range of values is $d_e = 1.3 - 4.6 \,\mu\text{m}$. This interval overlaps with the interval of d values, and average values of the compared parameters are also close: $d_{cp} = 1.91 \,\mu\text{m}$ and $d_{ecp} = 2.17 \,\mu\text{m}$.

Fig. 4. Surface of TiAlN coating with substructural defects, SEM: arrows indicate extrusion defects; in the center there is rectangular FIB cross-section
